Final Report

Bio-sorption Activated Media for Nitrogen Removal In a Rapid Infiltration Basin – Monitoring Project

Project Agreement No. NS 003

City of DeLand and University of Central Florida Project Team

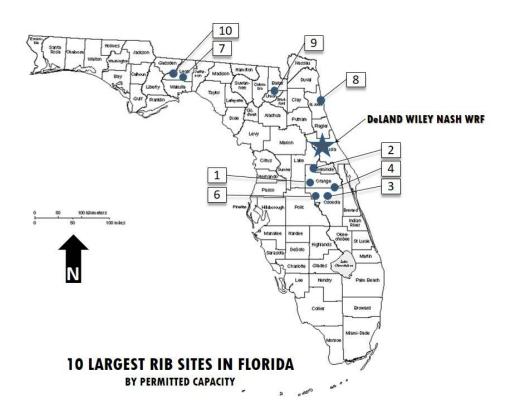
Figure 1 10 Largest WWTP sites utilizing RIBs in the state of Florida

Rapid Infiltration Basins (RIBs) have been widely used for decades with more than 350 domestic wastewater treatment plant sites utilizing them across the United States and around the world (USEPA, 2003). The primary focus of their use has been for groundwater recharge, effluent disposal, or a combination of both goals. More than 30 sites utilizing RIBs are in the state of Florida (FDEP, 2017). Figure 1 shows a map including the 10 largest RIB sites by permitted daily capacity. Table 1 lists those 10 WWTP sites by name, location, and permitted daily flow capacity. The RIBs at the DeLand WRF is the fifth largest.

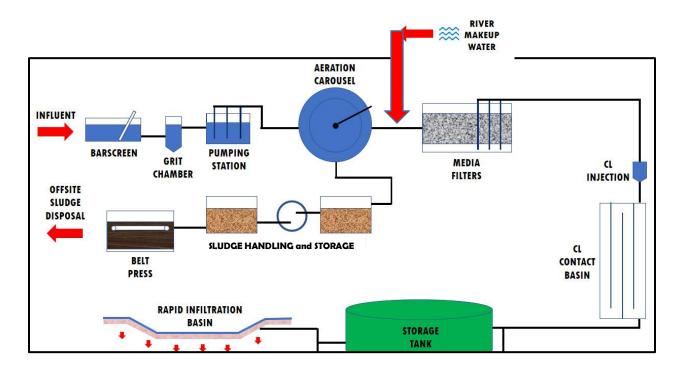
Following is a schematic of the DeLand WRF treatment process train (Figure 2). It is operated to produce reclaimed water for irrigation. In the process design, the DeLand WRF reduces nitrogen using a combination of aerobic and anoxic treatment zones. Currently, it is operated at about half the hydraulic capacity, thus providing an opportunity for additional pollutant removal. When there is not sufficient reclaimed water to meet irrigation demands, makeup water is delivered from the River. When there is excess reclaimed water in the storage tank, it is discharged to the RIBS. During flood conditions, the storage water can be a blend of reclaimed, river and stormwater. Thus, the RIBS while usually only disposing of excess reclaimed water can also dispose of a blend of water including excess stormwater.

Figure 2 Schematic process flow diagram for the DeLand WRF

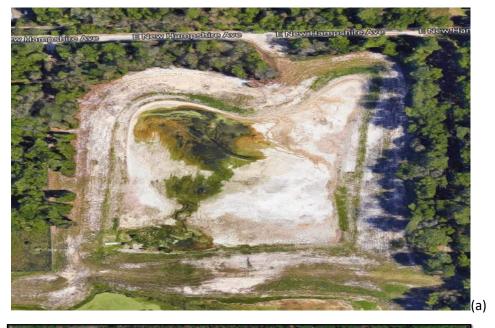
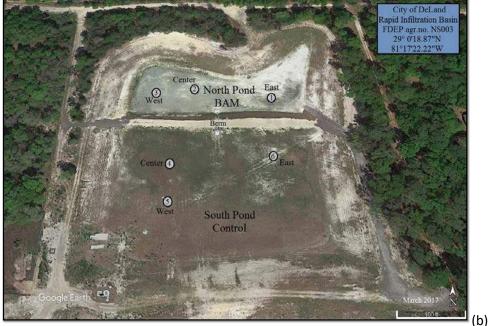
Figure 4 Aerial Photographs of (a) North (pre-study) RIB without separation berm and (b) BAM RIB (North) and Control RIB (South) with Lysimeter Locations

The RIB to be modified with BAM is part of a larger RIB site. The larger and smaller part of the RIB can be loaded independent of each other. Thus, minimal modification of the RIB plumbing was necessary. All the RIB areas are used by the City of DeLand for reclaimed and excess stormwater disposal when the water is not used for irrigation. Reclaimed water, river water and excess stormwater are pumped to the RIBs. The existing northern RIB is approximately 3 Acres and is shown in Figure 4. The location of the berm separating the BAM RIB from the Control RIB and the lysimeters is shown in Figure 4 (b).

The existing RIB was modified with a dividing berm. The dividing berm separates the RIB with BAM from the Control RIB (see Figure 4). The BAM RIB was constructed on the north side of the RIB and has 2 feet of BAM under an area of about 1 acre (43,600 SF). The Control RIB remained with the existing soil condition and is about 1.68 acres (73,200 SF). Figure 5 is the "as-built" plan. Reclaimed water

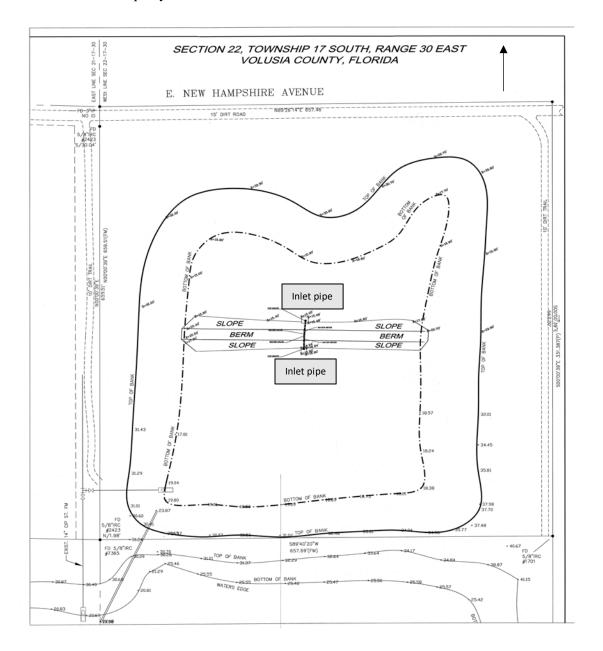
Figure 5 As-Built BAM and Control RIBS with Separating Berm (EFIRD Surveying Group, November 11, 2016, provided by the City of DeLand)

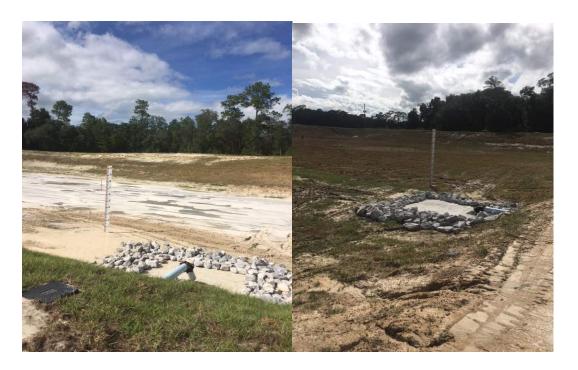
Staff gages were used to directly measure the water levels in both RIBs. Shown in Figure 6 are the staff gages for the BAM RIB and the Control RIB. Also shown are the inlet pipes that discharge water into the RIBS. The inlet pipes include vales and meters to distribute equally (on a RIB area basis) the same input flow rate from the reclaimed water reservoir of the Deland WRF.

(a) BAM RIB looking northeast

(b) Control RIB looking southwest

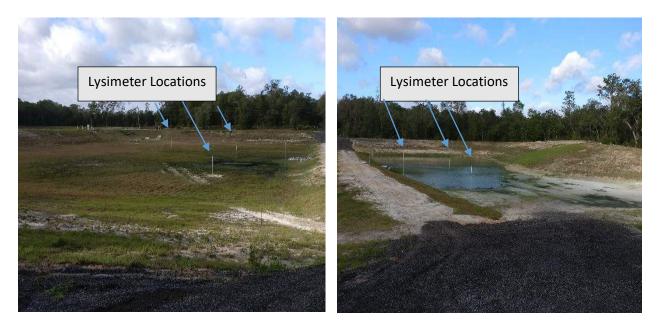
The experimental RIBs at the time nearing the end of a loading event are shown in Figure 7. The photos of Figure 7 were taken on February 25, 2017. The sampling lysimeters locations are shown.

Figure 7 Ground View of RIB (left side is Control RIB, right side is the BAM media RIB) with Lysimeter locations and Separation Berm

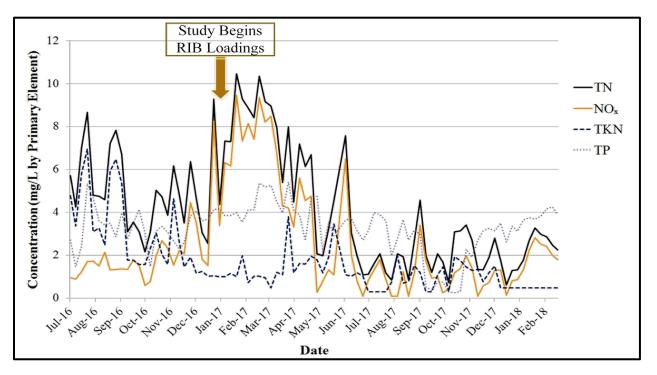
Sampling of the DeLand WRF effluent indicates changes in nutrient concentration over time. The plant is improving operation to remove nitrogen as shown by the monitoring data starting in July of 2017, and as shown in Figure 8 relative to other times. These changes are positive in terms of documenting the performance of the BAM RIB because the BAM RIB must operate to remove nitrates for a variety of DeLand WRF nutrient water quality conditions.

Figure 8 DeLand WRF Effluent Sampling (NOX (primarily nitrate), TKN, TN and TP) Source: City of DeLand Wiley Nash WRF Staff, September 2017 and March 2018

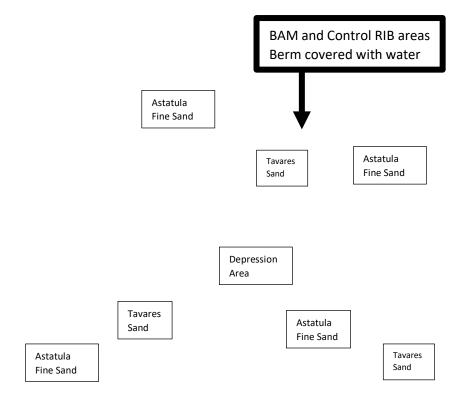
table restriction is about 1 inch per hour. The soil types at the surface are primarily sandy clay as shown in Figure 9 with clay layers approximately 2-4 feet below the bottom of the BAM and Control RIB areas.

Figure 9 Stormwater Storage Photo with US NRCS Soil Map

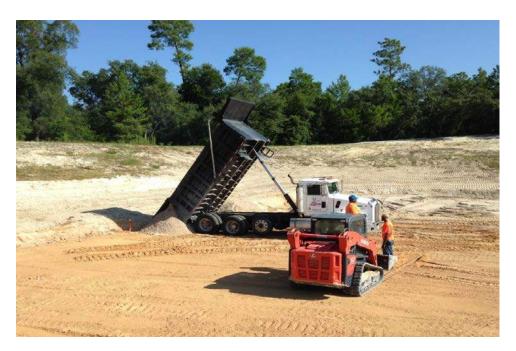
1. **The installation time for BAM:** The installation was completed in one week. City staff placed 3227 CY of BAM. The BAM was delivered in dump trucks (see Figure 10).

Figure 10 Installation of the BAM in the one-acre RIB

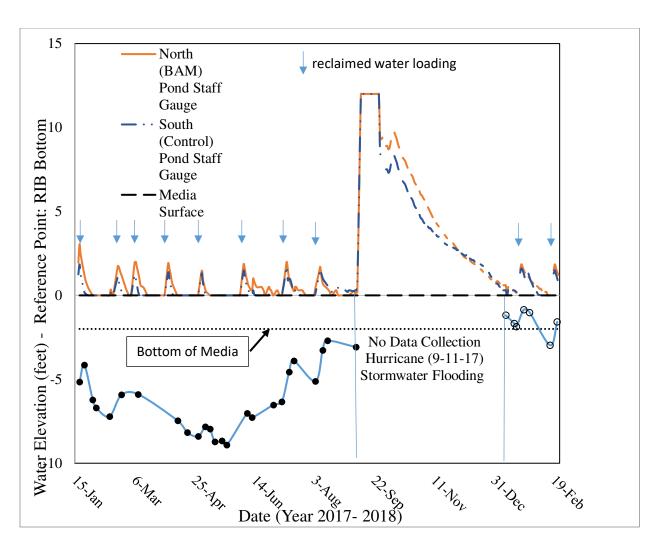
The depth of storage or gage heights shown in Figure 12 reflects the rate of loading over time and infiltration. Infiltration is the slope of the decreasing portion of depth over time. The stage data show no noteworthy difference in the stage and infiltration (slope of line) between the Control and the BAM RIB. The area under the stage curve times the area of water storage is the volume of storage. The time to empty the RIBs was about equal.

Also shown in Figure 12 is a comparison to the water table depth as a measure water in a well. The well was in the separation berm between the BAM RIB and the Control RIB. The RIBs were used to store excess stormwater during and immediately after the Hurricane. The depth of storage was greater than the top of the well-used to measure groundwater and was in a flooded condition up until the end of December. Thus, no data on well depths are available during that time. However, it can be seen that in the months of January and February the water table had risen to within 1-2 feet of the bottom of the RIBS. The rate of infiltration during this period decreased to about 0.125 to 0.25 inch/hour.

Figure 12 Depth of Water in the BAM RIB and the Control RIB

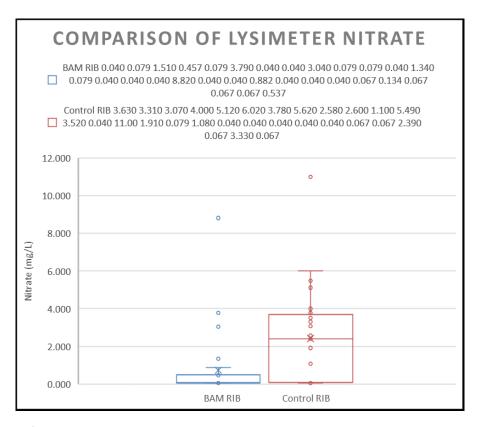
For visual presentation, a comparison of the reclaimed concentration data is shown in a "box" plot of Figure 13. Data used for "box" plots are shown as circles and a listing is in Figure 13. For the BAM RIB, there were 30 samples (3 for each loading event). For the Control RIB there were 29 samples (lysimeter 4 failed to deliver a sample one time). A listing of the data is also in Table 4(a). The reduction in concentration is greatest with the use of BAM.

Legend: Reference EXCEL 2016: average x, minimum ⊥_, maximum ⊤_, Quartiles −−−− Figure 13 Comparison of Nitrate under the BAM and Control RIBs Using Reclaimed Water

4. When loading with reclaimed water, the concentration of nitrates in the lysimeters two feet under the surface of the RIBs was measured: The average and median concentrations under the BAM RIB were 0.73 mg/L and 0.079 mg/L respectively (basically the detection limit). There were three (8.82, 3.04 and 3.79) values of nitrates which account for some of the difference between the medium and average. Two measurements were identified as a lysimeter failure when the lid of lysimeter 3 was partially off and sediment (clay soil from the surrounding soil) was found inside. The lid was reset after the March 2017 sampling event. The average and median concentrations under the Control RIB were 2.40 and 2.39 mg/L. Lysimeter 4 within the Control RIB was replaced after the March sampling because it did not yield sufficient sample. It was found to be one foot under the bottom of the Control RIB. It was replaced at a depth of 2 feet.

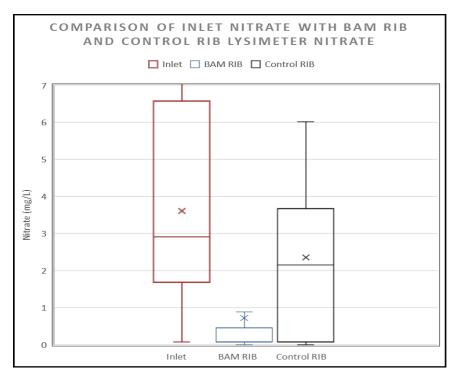
5. When loading with reclaimed water, the lysimeter nitrate concentrations are compared to the inlet nitrate concentration: The inlet nitrate concentration was directly measured in the reclaimed reservoir during the loading of the RIBS. However, for two samples (January and May of 2017), the inlet measure was from the discharge from the DeLand WRF. The discharge from the DeLand WRF is into the reclaimed reservoir. The reclaimed reservoir is the storage area (tank and pond) from which the water is used to dose the RIBs. The reclaimed storage area is about 6.4 MG. The DeLand WRF produces about 3 MGD. There were ten loading events with reclaimed water. The comparison of inlet nitrate concentrations to those in the lysimeters is shown in a "box" plot of Figure 14. From Figure 14, the reduction in concentration is greatest with the use of BAM.

Legend: Reference EXCEL 2016: average x, minimum ___, maximum ___, Quartiles _____
Figure 14 Comparison of Inlet and Lysimeter Nitrate Concentrations Using Reclaimed Water

6. When loading with reclaimed water, the average percent removal for nitrate can be calculated: When using BAM, the average percent removal of nitrate when loading with reclaimed water (inlet nitrogen > 1.51 mg/L) was 89%. When loading with lower concentration reclaimed water (less than 0.723 mg/L) there were 11 of 14 samples less than detection, thus no removal could be estimated. The lower concentration most likely resulted from wastewater treatment process changes and the addition of river water to the irrigation storage reservoirs. Over half the time nitrate removal using BAM exceeds 97% (median removal value).

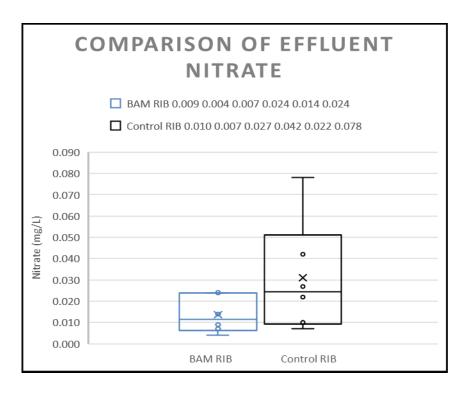
Figure 15 Comparison of Lysimeter Nitrate Concentrations using Excess Stormwater

8. When loading with excess stormwater, the average percent removal for nitrate was calculated: In the RIBs, the maximum depth of excess stormwater loading from Hurricane Irma was about 12 feet. No more water could be added as 12 feet was the maximum depth. Sampling the lysimeters for water quality continued when the depth of water receded to 2 feet. Thus, a composite sample was taken on December 18 for the initial infiltration of water. A second sample was taken after the lysimeters were evacuated of sample. The sample dates for the six lysimeters were December 18, 2017 and January 10, 2018. The procedure of evacuated between sample dates was the same as when reclaimed water was used. The collected stormwater samples were analyzed by ERD, a certified lab within 24 hours after collection. The parameter analyzed by ERD were nitrate/nitrite (NOx). The results are shown in Figure 15 with the data and statistics shown in Table 4b. The concentration of Nitrate was lower in the BAM RIB lysimeter when compared to the Control RIB lysimeter. This was an unfortunate hurricane event but provided real data for evaluation as there was excess stormwater of sufficient quantity to help load the RIB at a significant depth (12 feet compared the about 16 feet when using reclaimed water).

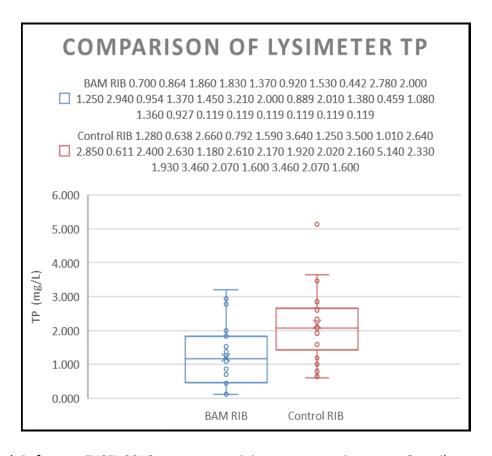
For visual presentations and calculation of statistical measures, a comparison of all the data is shown in a "box" plot of Figure 16. Data used for "box" plots are shown as circles and a listing is in Figure 16. For the BAM RIB, there were 30 samples (3 for each loading event). For the Control RIB there were 29 samples (lysimeter 4 failed to deliver a sample one time). It was reset for the next loading event. A reasonable explanation for the removal of total phosphorus for both the BAM RIB and the Control RIB at 2 feet below the surface is the occurrence of tire crumb in the BAM and clay particles in both. Straining of the particulates and chemical removal of the dissolved species are the most likely removal mechanisms.

Legend: Reference EXCEL 2016: average x, minimum ___, maximum ___, Quartiles _____
Figure 16 Comparison of Lysimeter Total Phosphorus Concentrations using Reclaimed Water

9. When loading with reclaimed water, the concentration of total phosphorus (TP) in the lysimeters which are two feet under the surface of the RIBs were recorded and evaluated: The average and median nitrate concentrations under the BAM RIB were 1.21 mg/L and 1.17 mg/L. The average and median concentration under the Control RIB were 2.18 and 2.07 mg/L. Lysimeter 4 within the Control RIB was replaced after the March sampling because it did not yield sufficient sample. Upon inspection it was found to be only one foot under the bottom of the Control RIB and thus was replaced at the appropriate depth of 2 feet.

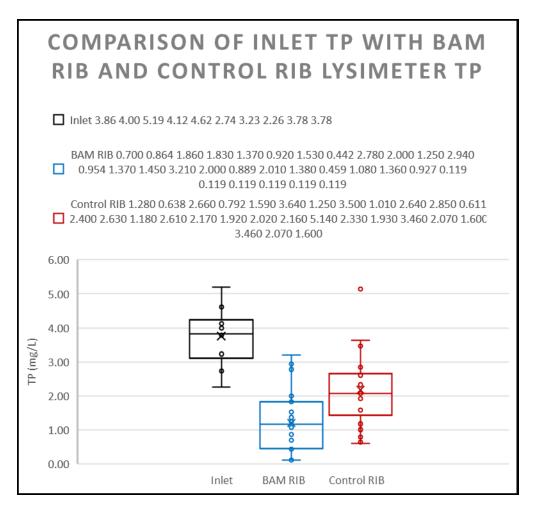
10. Comparison of the lysimeter total phosphorus concentration to the inlet phosphorus concentration when using reclaimed water was made: The inlet phosphorus concentration was directly measured in the reclaimed reservoir during the loading of the RIBS. However, for three samples (January, March and May 2017), the inlet measure was from the discharge from the DeLand WRF. The discharge from the DeLand WRF is into the reclaimed reservoir. The reclaimed reservoir is the storage area (tank and pond) from which the water is used to dose the RIBs. The reclaimed storage area is about 6.4 MG. The DeLand WRF produces about 3 MGD. There were ten loading events. The comparison of inlet total phosphorus concentrations to those in the lysimeters is shown in a "box" plot of Figure 17. From Figure 17, the reduction in concentration is greatest with the use of BAM, however the Control BAM with clay reduces the total phosphorus, but the reduction is not as great as BAM is used.

Legend: Reference EXCEL 2016: average x, minimum ___, maximum ___, Quartiles _____ Figure 17 Comparison of Inlet and Lysimeter Total Phosphorus Using Reclaimed Water

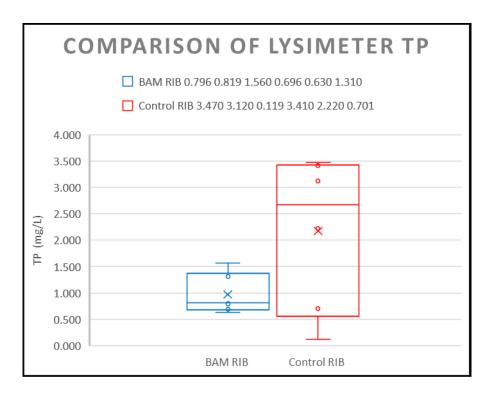
12. When loading with excess stormwater, the concentration of total phosphorus (TP) in the lysimeters which are two feet under the surface of the RIBs were recorded: The data are shown in Table 5(b). Under the BAM, the average and median total phosphorus concentrations were 0.97 and 0.81 mg/L respectively. The total phosphorus standard for discharges from advanced wastewater pollution control facilities in the State of Florida is 1 mg/L. Under the Control RIB, the average and median total phosphorus concentrations were 2.17 and 2.67 mg/L respectively. Based on the limited sampling, BAM removed more phosphorus than the natural soils in the Control RIB. There were no measures for inlet total phosphorus concentrations during Hurricane Irma, no any from other sampling sites in Florida.

Figure 18 Comparison of Lysimeter Total Phosphorus Concentrations Using Stormwater

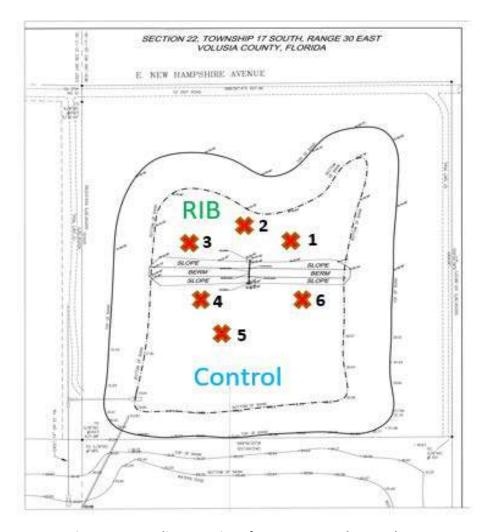
Sampling was conducted at locations near the lysimeters, and at multiple vertical locations in the Control and BAM RIBS. The samples were collected on two separate occasions, on February 2, 2017 and February 16, 2018. For each sample date, 18 samples were collected, leading to a total of 36 collected samples. The method for sample collection is explained below, with sampling locations for BAM RIB and Control RIB in Figure 19, and the depth profile in Figure 20.

Figure 19 Sampling Locations for BAM RIB and Control RIB

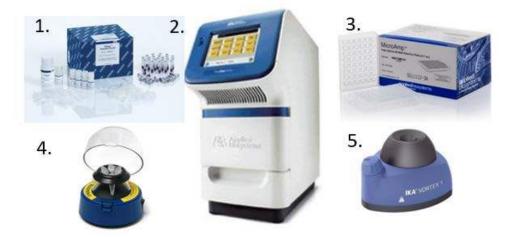
Figure 22 qPCR instrument and Accessories used in UCF Lab (1. DNeasy PowerSoil kit, 2. Applied Biosystem StepOne Real-Time PCR System, 3. PCR 48-well plate, 4. Centrifuge, 5. Vortex mixer)

Figure 22 is shown to validate the DNA method of analysis as other lesser accurate instruments can be used. These are the highest-grade instrumentation.

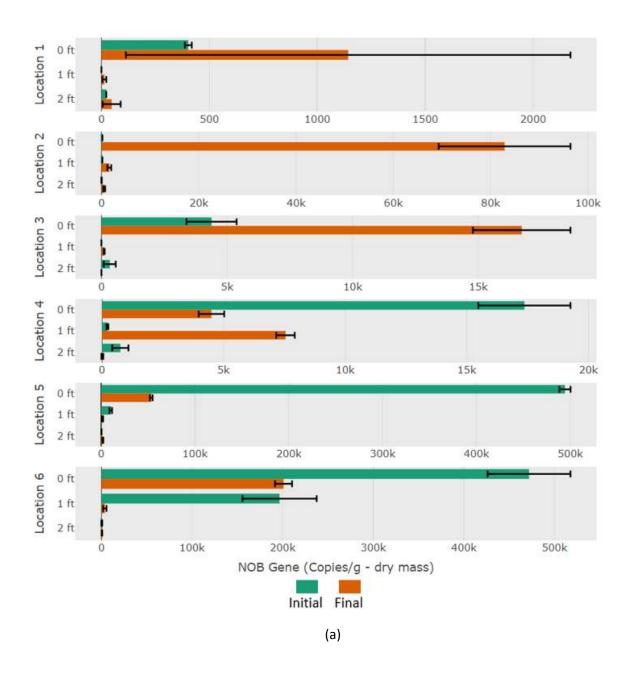
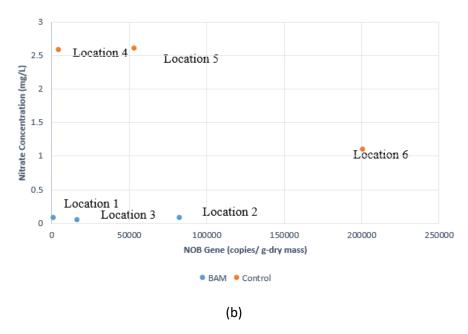
Results from second sampling event for the NOB show that the optimum depth for nutrient removal was at the surface layer for BAM RIB, and only at locations 5, and 6 for Control RIB (Fig. 23 (a)). The increase presence of NOB, 1 foot below the surface at location 4 can be attributed to ponding effect. The ponding of reclaimed water at this location could have affected adsorption of nutrients in the soil consequently affecting the NOB activity by reducing oxygen in the top layer. The accumulation of nutrient at the surface on the RIB provided the required environment for microbial growth. Ashe quantity of NOB is associated with nutrient availability in the soil and nitrogen removal. The increase in NOB population in the BAM RIB from the first and second sampling event demonstrate the relationship between microbial population and nitrate removal. The more NOB available at the BAM RIB the more microbiological activity present by NOB to convert nitrite to nitrate.

Figure 23 (a) NOB Gene for BAM (Locations 1, 2, and 3) and Control (Locations 4, 5, and 6) in initial (2/2/2017) and final (2/16/2018) sampling, (b) Comparison of nitrate concentration and NOB gene at surface layer for BAM and Control RIB for locations 1-6 for second sampling event for nitrate removal.

The difference in NOB and denitrifier population in the distinct depths (0, 1, 2 ft) for both the BAM and Control RIBS for first sample data is due to the initial state of the project. Initially the organisms require time to stabilize before a consistent trend is observed. The inlet water nitrogen concentration varied adding to the required microbial adjustment. A trend of decreasing NOB population with depth is observed at the final stage for all the locations apart from location 4, which has an increase in NOB population at depth of 1 foot before decreasing (Fig. 23(a)). Further, NOB increased

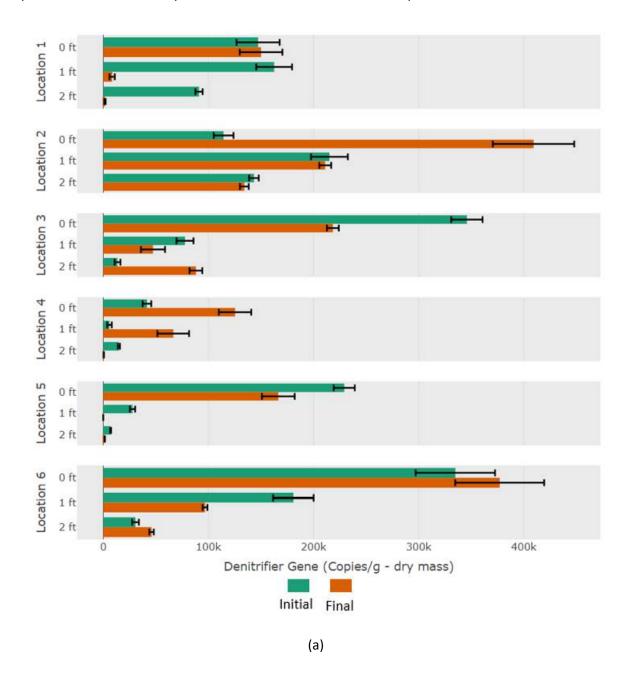
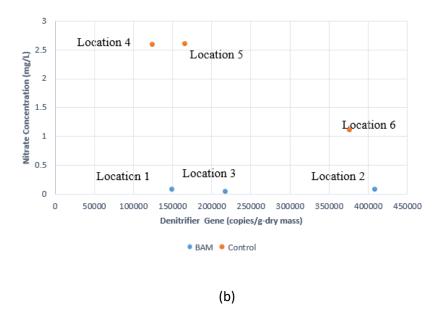
was observed in the BAM RIB (Fig. 24 (a)). Additionally, denitrifier gene show the largest gene population at the surface of location 2 of BAM RIB (Fig. 24 (a)). This is associated with the previously observed high nitrate removal of BAM (89% overall; 82% with reclaimed water and 95% with stormwater) as opposed by the Control (40% with reclaimed water and 90% with stormwater) (Table 10). This is related with the denitrifier population in the BAM RIB which had high denitrifier gene population opposed to the Control RIB. The largest denitrifier population of approximately 409,330 copies/ g-dry mass occurred on BAM RIB (Table 11(a)), compared to approximately 377,146 copies/ gdry mass at Control RIB for the second sample event (Fig. 24(a)). The greater presence of denitrifier population in BAM contributes to an increase in nitrate reduction in BAM RIB as these organisms convert nitrate to nitrogen. This is supported by the higher nitrogen removal observed for the BAM RIB even with the low concentrations of nitrate in BAM RIB in comparison with Control RIB (Fig.24(b)). As a result, the denitrifier population can be associated with the observed nitrogen removal. The increase of the denitrifier bacteria quantity in the BAM RIM from the first and second sampling events coincides with nitrogen removal. With an increase denitrifier population, more denitrifiers are available for the conversion of nitrate to nitrogen. The more denitrifiers present in the soil, the greater microbiological activity can be observed.

Figure 24 (a) Denitrifier Gene for BAM (Locations 1, 2, and 3) and Control (Locations 4, 5, and 6) in initial (2/2/2017) and final (2/16/2018) sampling, (b) Comparison of nitrate concentration and denitrifier gene at surface layer for BAM and Control RIB for locations 1-6 for second sampling event for nitrate removal.

at location 2 for second sampling date. The denitrifier follows a similar trend where the population decreases with depth for most of the locations in the final stage (Fig. 24(a)). As a result, the properties of BAM media contributed to NOB and denitrifier growth and microbiological process in nitrate removal (O'Reilly, Wanielista et al. 2012). In contrast with the Control RIB, nutrient removing bacteria cultivation was supported in the BAM RIB, this is related to the physiochemical properties of this media. The efficiency of BAM for nitrate removal is related to microbial activity and quantification, as the highest nitrate removal was performed by the BAM RIB. Figure 7, and 8 summarize the total NOB and denitrifier gene population present in the BAM and Control RIBS, and its relation to nitrate removal.

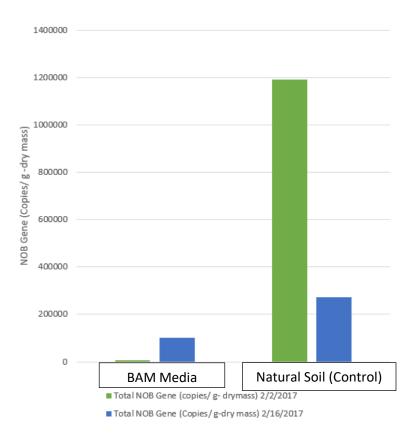
Figure 25 Comparison of total NOB population for BAM and Control RIB for two sampling events and corresponding nitrate removal efficiency.

For example, in the initial stage when the first soil sampling event occurred the NOB gene population was more abundant for the Control RIB as opposed to the BAM RIB. A similar relation is observed for the denitrifier gene population in the majority of sample locations for the first sampling event. An explanation for the presence of a large quantity of NOB and denitrifier bacteria in the Control locations for the first sampling event is possible moisture content related with clay in the soil. The moisture provided adequate environment for the bacteria to be sustained. As time progresses and the NOB and denitrifier organisms established in the soil of the BAM and Control RIBs, the population stabilized to the populations observed with the second sampling event, one year after the first sampling took place.

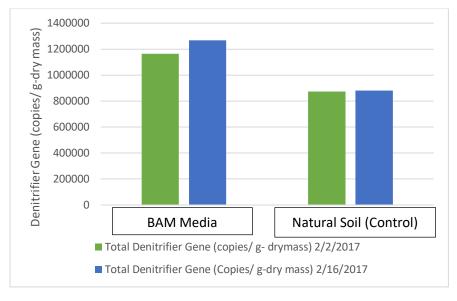
Figure 26 Comparison of total denitrifier population for BAM and Control RIB for two sampling events and corresponding nitrate removal efficiency.
